North Coast Regional Water Quality Control Board

Inspection Report

Site: Gary VanDenBerghe, Mendocino County APN 056-170-10-00

Inspection Date: April 3, 2018

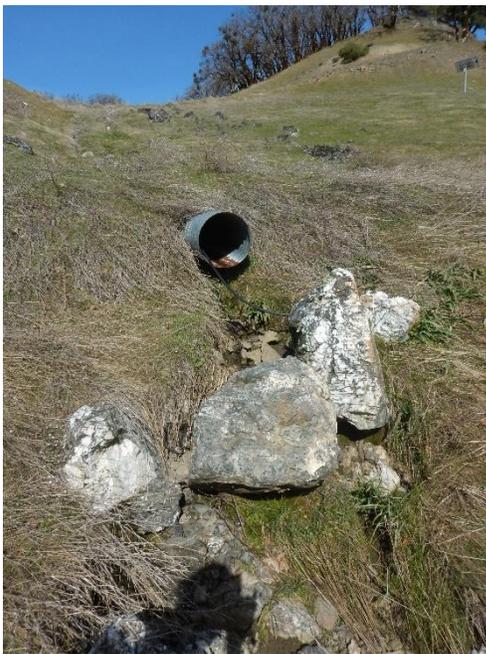
We accessed the Property via a long driveway off of Spy Rock Road, approximately 15 miles east by southeast of Leggett. Along the driveway, I observed four culverted stream crossings, identified as inspection points C1-C4. The culvert at C4 consists of an 18" corrugated metal pipe (CMP) with a slightly shotgunned outlet, and lacking sufficient armoring at the outfall to prevent/minimize erosion (Photo 1). The culvert at C3 consists of a 12" CMP that relieves the inboard ditch of the road and discharges into a class III watercourse (Photos 1-2). The culvert outlet is slightly misaligned from the channel and lacks adequate armoring to prevent/minimize erosion at the outfall. The culvert at C1 consists of a 24" CMP that conveys a class II watercourse under the access road; the culvert outlet is slightly shotgunned and lacks adequate armoring to prevent/minimize erosion at the outfall (Photos 3-4). The culvert at C2 consists of an 18" CMP that is partially occluded at both the inlet and outlet, and is not correctly aligned with the class III stream channel that it conveys. Outflows drain onto the hillslope before returning to the natural channel (Photos 5-7). On the watercourse channel upstream of the C2 inlet, I saw a structure (labeled S1), apparently used for storage, with assorted containers and bins (Photos 8-9).

Photo 1 - C4 Outlet

1. Engage appropriately qualified, licensed professional(s) to develop a plan, including design and construction standards and an implementation schedule to repair and/or replace stream crossings C1-C4, identified in this report.

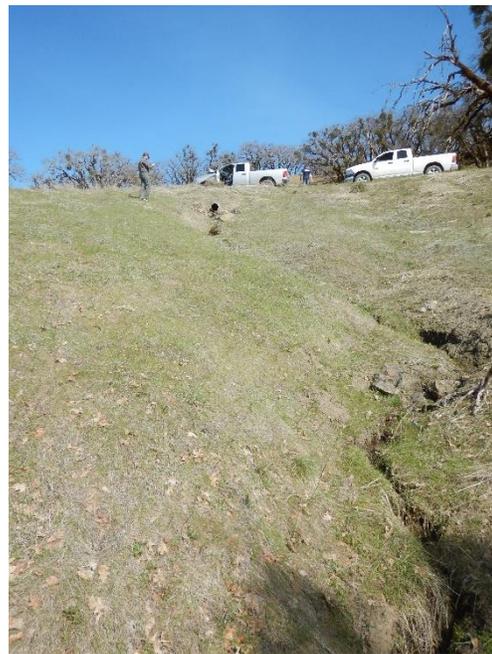
Photo 2 - C3 Outlet and Class III channel

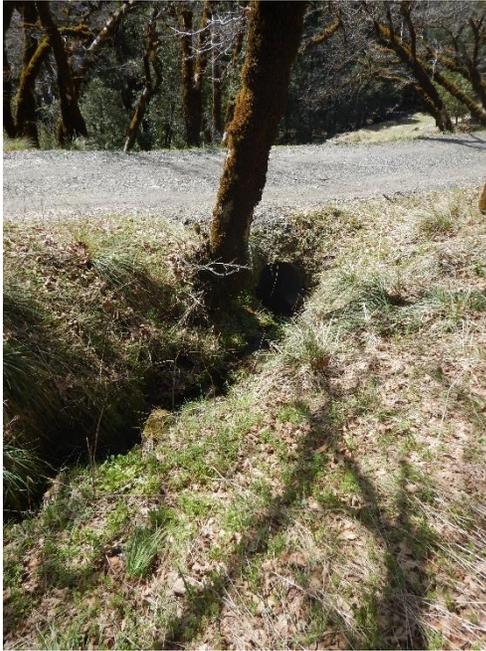
Photo 3 - C1 Inlet

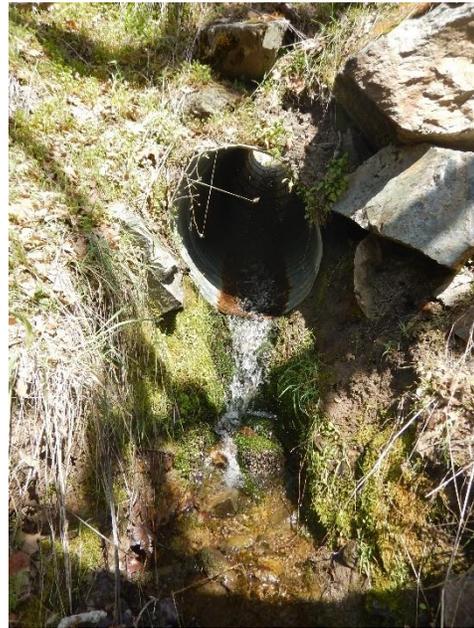
Photo 4 - C1 Outlet

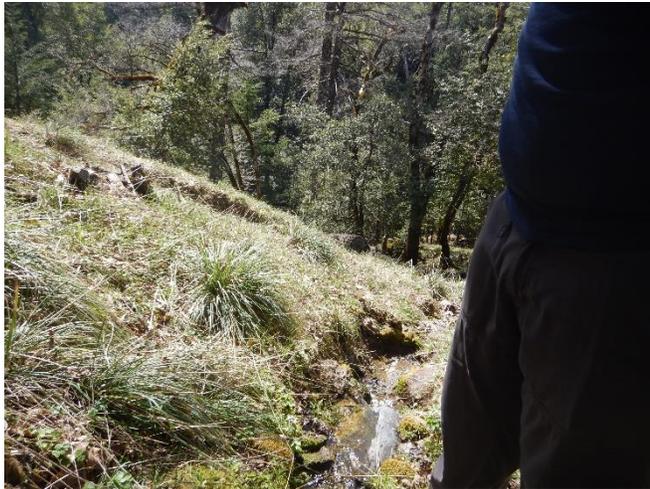
Photo 5 - Channel Downstream of C1

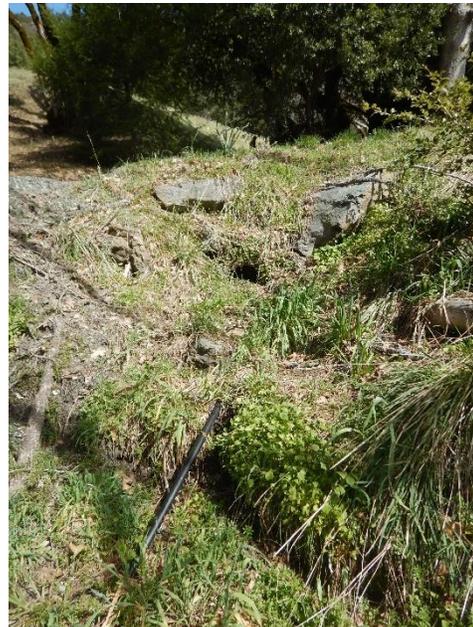
Photo 6 - C2, partially occluded outlet

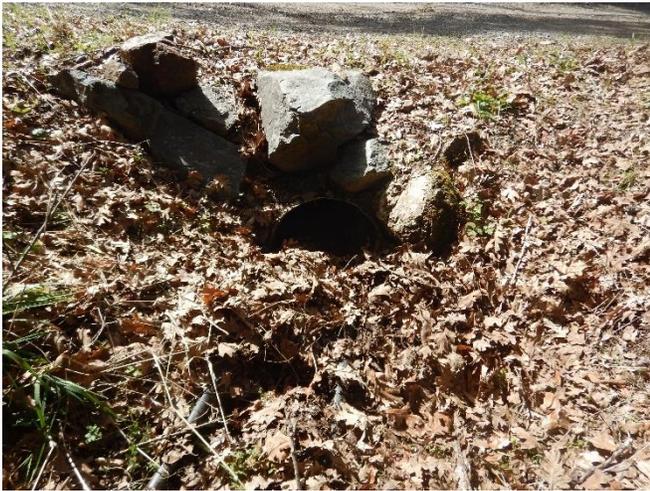
Photo 7 – C2, partially occluded inlet

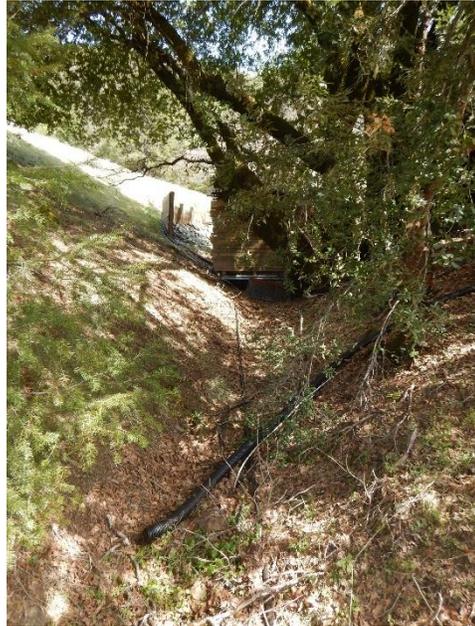
Photo 8 – C2 Upstream, with structure in watercourse

- c. Riparian and Wetland Protection and Management: I observed no water quality concerns relating to Riparian and Wetland Protection and Management, however, as noted above, I observed a storage structure sitting in a class II watercourse channel.

4. Remove the storage structure from the watercourse upstream of crossing C2, and ensure that storage facilities/features are located away from surface waters and active drainageways. Restore any associated disturbance to the watercourse channel and/or adjacent riparian areas.

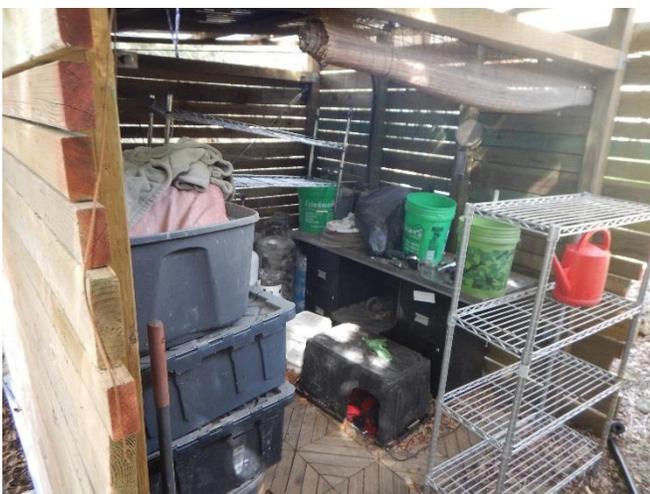
Photo 9 – Contents of structure upstream of C2

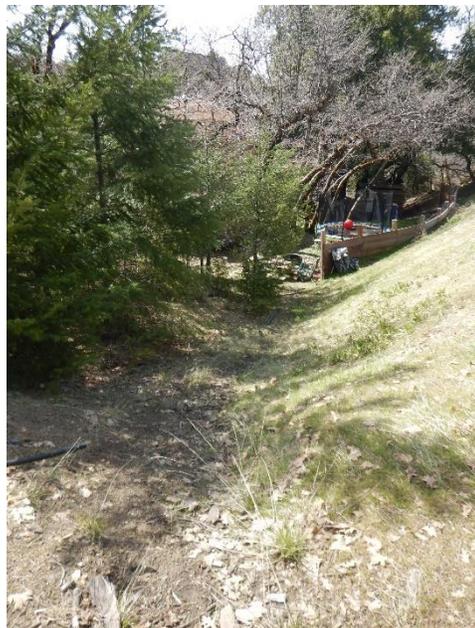
Photo 10 - Channel upstream of structure upstream of C2, pond P1 dam on right side of channel

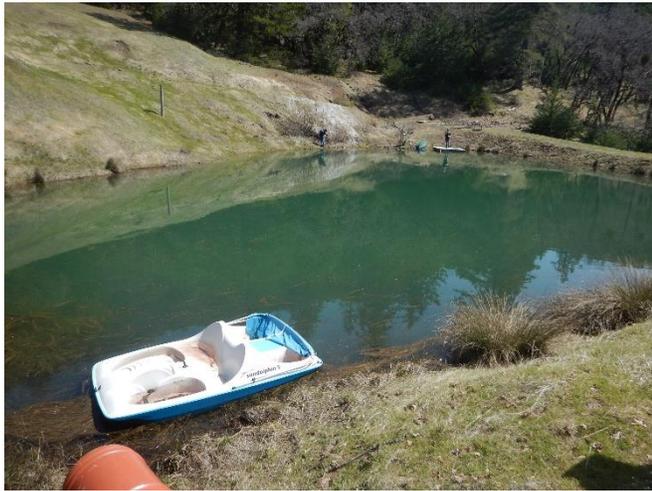
Upstream of the storage structure, along the same watercourse, I observed an impoundment, identified as inspection point P1. The pond at this location is fed by two class III watercourses blocked by a large earthen dam (Photos 11-12). Along the dam, I observed several cracks that appeared surficial, but would require further investigation to determine the full extent of cracking and to identify any associated concerns with the stability of the berm (Photo 13). The pond outfall consists of an 18" CMP that is partially occluded at both the inlet and outlet and lacks adequate armoring to prevent/minimize erosion at the outlet (Photos 14-16). The pond is approximately 10 years old, based on imagery review.

Photo 11 - P1, Class III channel inlet visible

2. Submit an evaluation of the pond embankment identified at P1 in this report, prepared by a qualified, appropriately licensed professional. The evaluation should, at a minimum, characterize the stability of the embankment and outflow structure and flow path. Recommended performance standards are that the berm has slopes not more than 2H:1V and exhibits no cracking or slumping; the pond is maintained to have at least 2' of freeboard; the outflow conveyance structure is adequately sized to pass the 100-year recurrence interval expected outflow plus debris; and the outlet does not exhibit actual or threatened erosion and sediment discharge to surface waters. Based upon the assessment, submit a plan and schedule for corrective actions of P1.

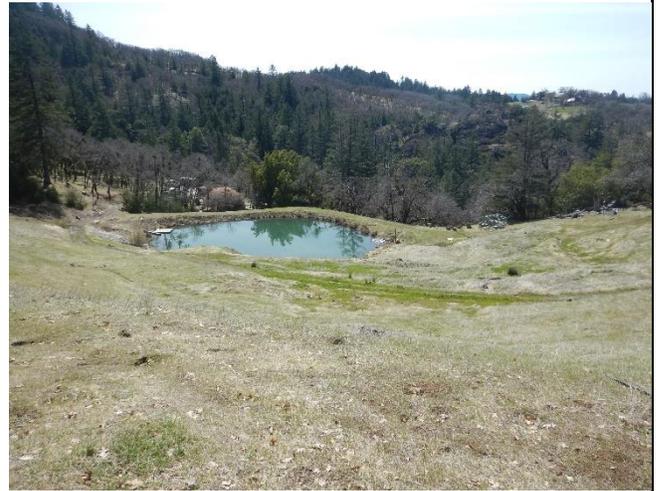
Photo 12 - P1 Overview

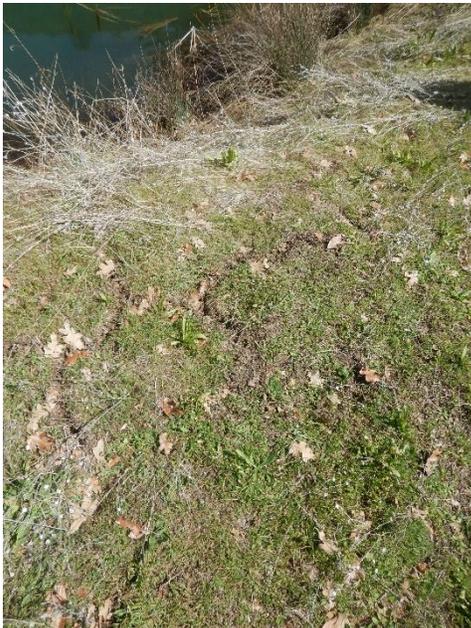
Photo 13 - P1 dam with shallow surface cracking visible

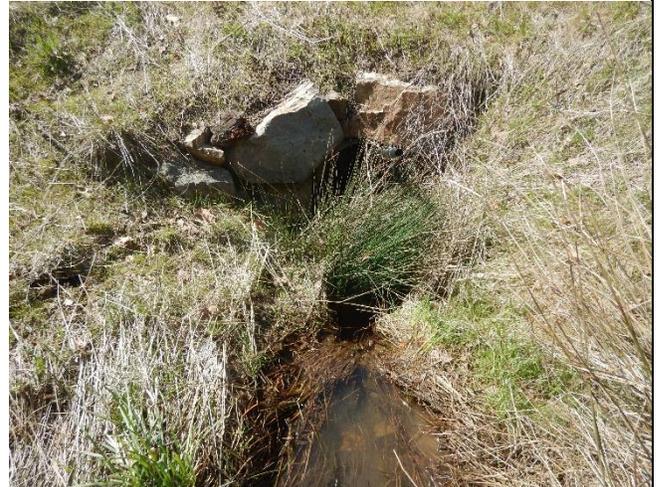
Photo 14 - P1 outfall inlet

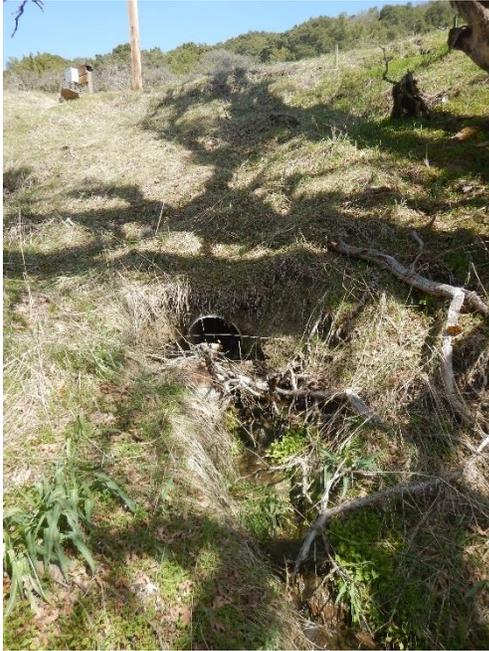
Photo 15 - P1 Outlet

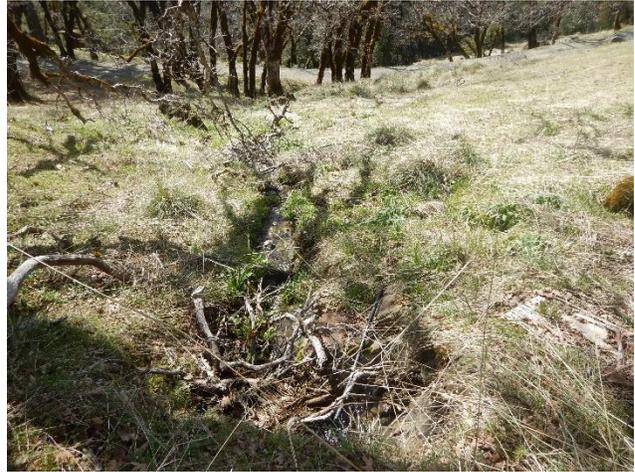
Photo 16 - Channel below P1 outlet

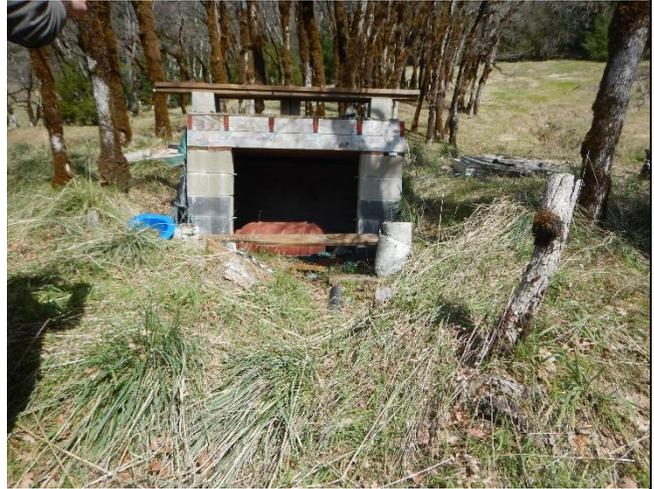
Southeast of crossing C2, along the northwest side of the access road, I observed multiple homestead structures (not photographed) immediately downslope from pond, P1. On the other side of the access road, I observed a platform structure, labeled as Pit1, that appeared to be used as a pit toilet. At the base of the pit toilet structure, I observed a plastic pipe leading away from structure down the hill towards a Class II watercourse less than 100 feet downslope (Photos 20-21).

Pit1	Pit Toilet Platform	Pit Toilet platform and infrastructure with outlet directing potential discharge along a slope towards a class II watercourse.	20-21

<i>Inspection Point</i>	<i>Brief Description</i>	<i>Water Quality Concern</i>	<i>Associated Photo(s)</i>
Pit1	Pit Toilet Platform	Human waste handling system potentially not in compliance with applicable county requirements. Discharges and/or threatened discharges to surface waters	20-21

Photo 20 -Pit Toilet platform.

6. Discontinue use of and dismantle any outhouse/pit toilet features and work with Mendocino County to ensure that all domestic and human wastes are collected and disposed of consistent with applicable County requirements.
7. Work with CDFW and the State Water Resources Control Board's Division of Water Rights (DIV) to determine and secure any applicable permits or licensing required for surface water diversion, storage, and use on the Property, including the instream and pond diversions.
8. Update and submit to Regional Water Board staff a copy of the WRPP for this site, incorporating/addressing the recommendations provided herein.
9. By July 1, 2019, transition enrollment of this property from the North Coast Regional Water Quality Control Board Order R1-2015-0023 to the State Water Resources Control Board Cannabis General Order No. WQ-2017-0023.

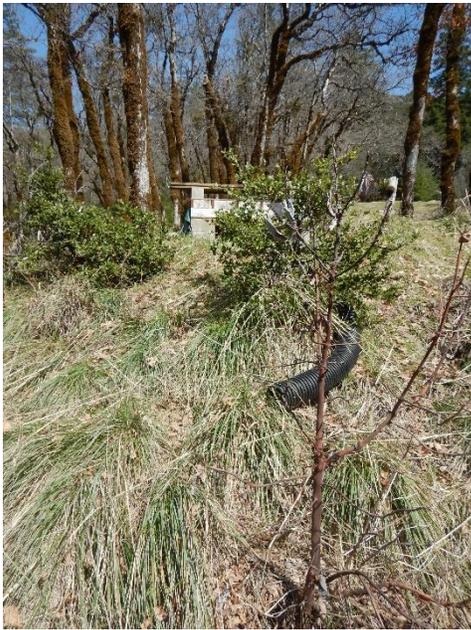
Photo 21 - Outlet of pipe from apparent pit toilet.

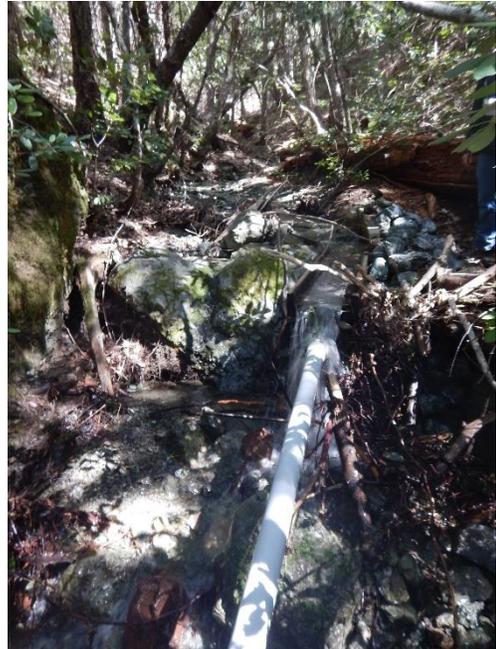
In the class II watercourse, upstream of US1, I observed a surface water diversion feature (POD1) consisting of a wooden chute structure leading to a 2" diameter plastic pipe that diverts the majority of the flow from the watercourse (Photo 22). I followed the diversion pipe to its terminus, several hundred feet downstream, labeled "overflow" on Figure 1, where I observed multiple lines leading into pickle barrels, overflow lines feeding excess water back into the class II watercourse, and others being directed upslope towards the residence and cultivation sites (photos 23-24).

Photo 22 - Intake of POD on CII Watercourse

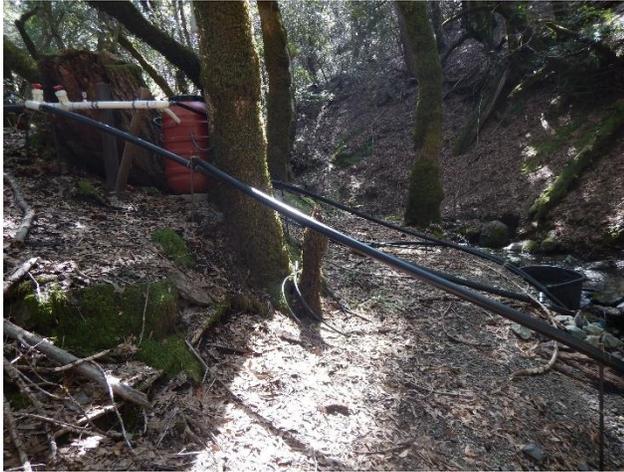
Photo 23 – POD pump system and overflow

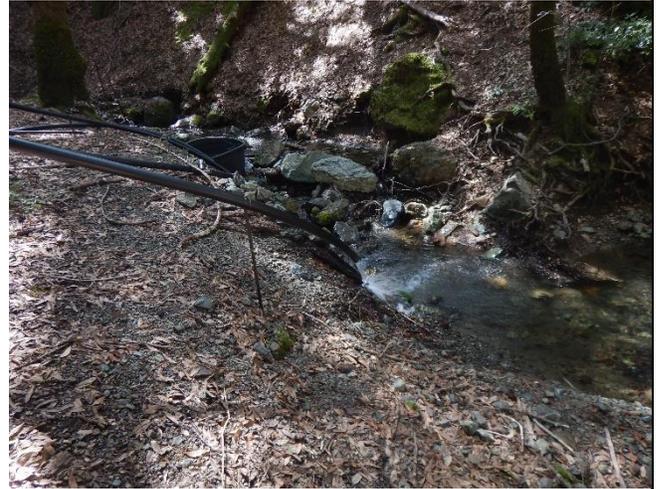
Photo 24 – Overflow actively discharging back into CII watercourse

- d. Spoils Management: I observed no water quality concerns associated with spoils management on the Property.
- e. Water Storage and Use: I observed a diversion point within a class II watercourse, as well as unregulated overflow from the diversion point discharging back into the watercourse several hundred feet downstream. Additionally, I observed an onstream impoundment with a berm that had cracking visible and an outfall that may be undersized for the expected flow and is not armored to prevent erosion and sediment discharge.

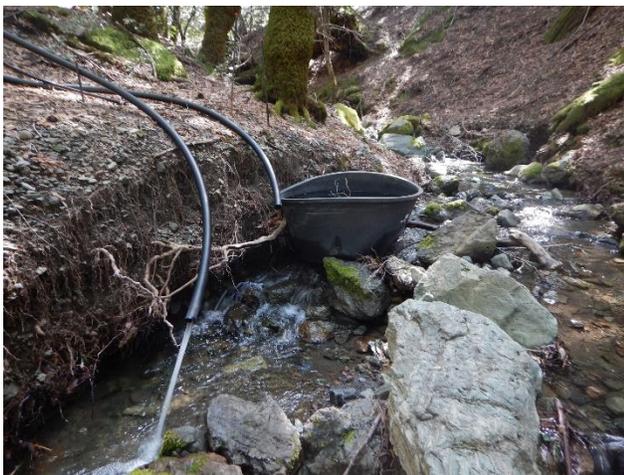
Photo 25 – Overflow actively discharging back into CII watercourse. Refuse in watercourse.

5. Collect and dispose of or contain all refuse and cultivation-related wastes in a location and manner so as to minimize potential for these wastes to enter or be transported into receiving waters.

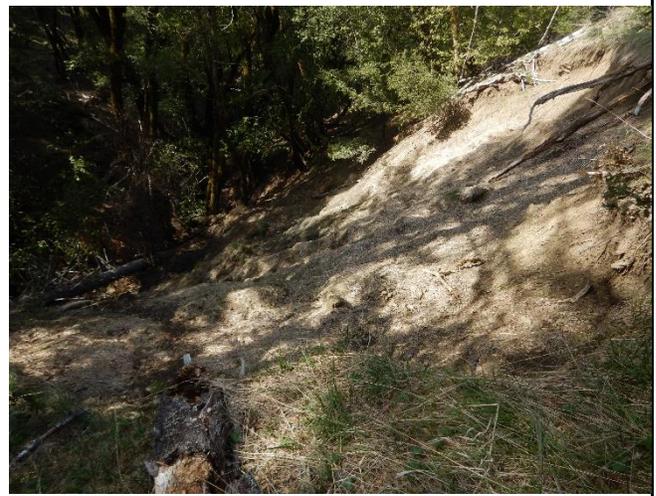
Several feet downslope from the pit toilet structure, I observed a large scarp and unconsolidated soils that had slumped towards the class II watercourse below (Photos 26-28), labeled US1 on Figure 1. I did not identify an apparent cause for the slumping, but the access road, pit toilet, and various other structures are all located just upslope of the failure.

Photo 26 – Downslope view of US1 immediately downhill from apparent pit toilet platform and adjoining road.

- a. Site Maintenance, Erosion Control and Drainage Features: In addition to the features mentioned in b., c., and e., below, staff observed a large unstable area that has the potential to deliver to a class II watercourse, US1.

3. Submit an evaluation of the unstable feature identified as US1 in this report, prepared by a qualified, appropriately licensed professional. The evaluation should characterize the feature, including likely contributing factors, activity level, a description of potential future sediment delivery, and identify feasible sediment control strategies to prevent and minimize additional sediment delivery. Based upon the assessment, submit a plan and schedule for corrective actions at US1

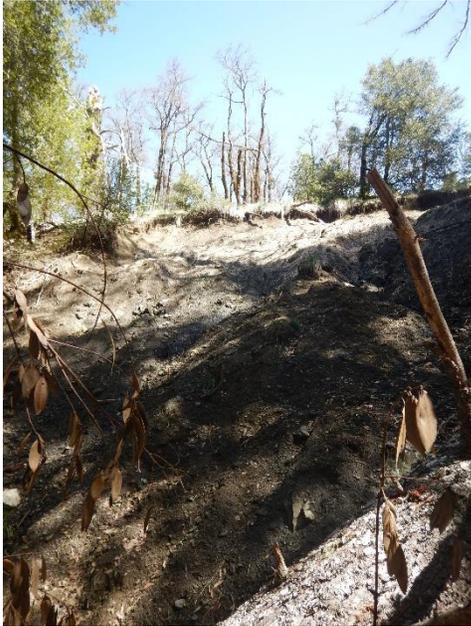
Photo 27 – Upslope view of US1

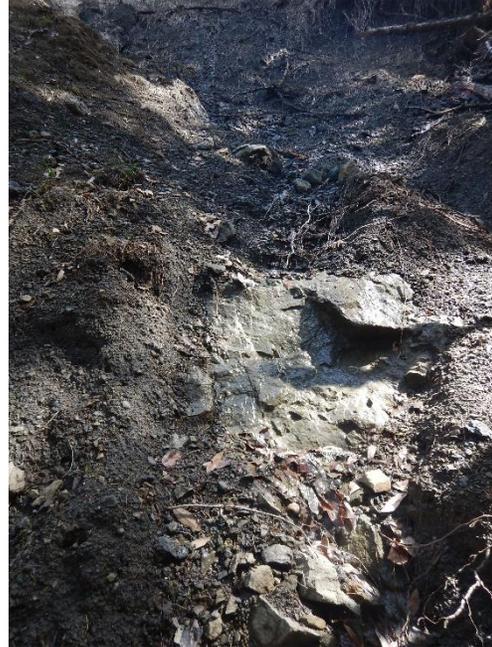
Photo 28 – Channel cutting through US1, upslope view.

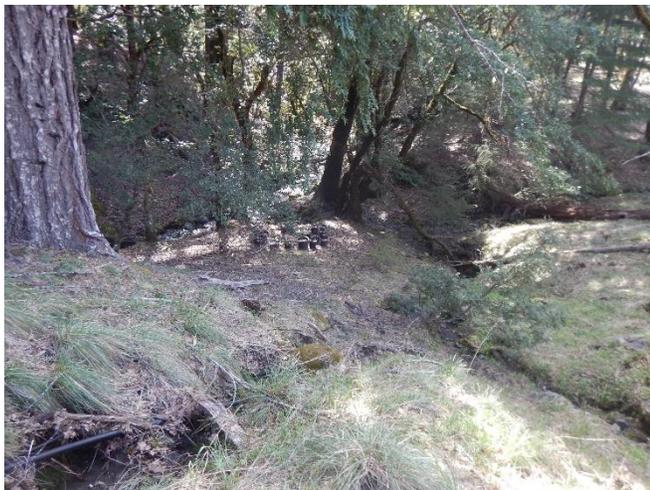
At several locations throughout the parcel, I observed refuse and cultivation-related wastes strewn about in locations where they have the potential to enter waters of the state (photos 29-32).

Photo 29 – Discarded cultivation pots adjacent to watercourse

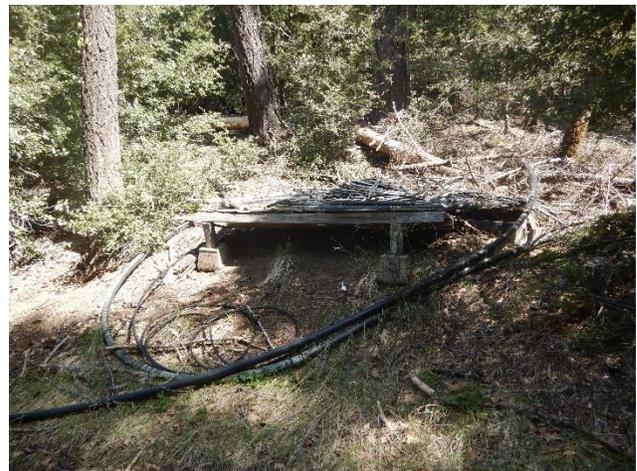
Photo 30 – Discarded hosing near main residence

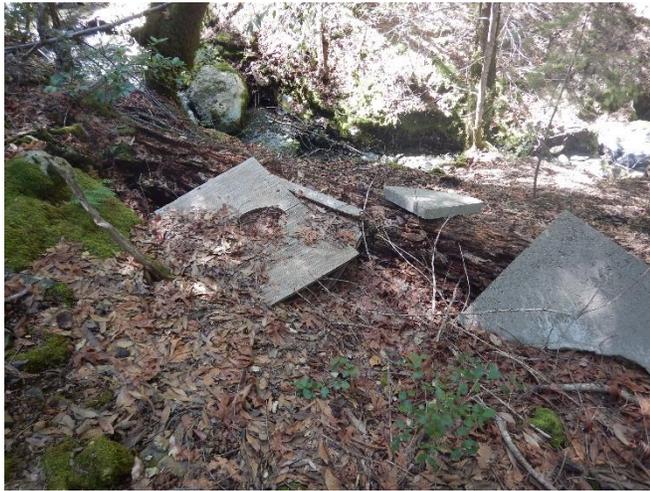
Photo 31 – Out of use outhouse along CII watercourse, downhill from residence

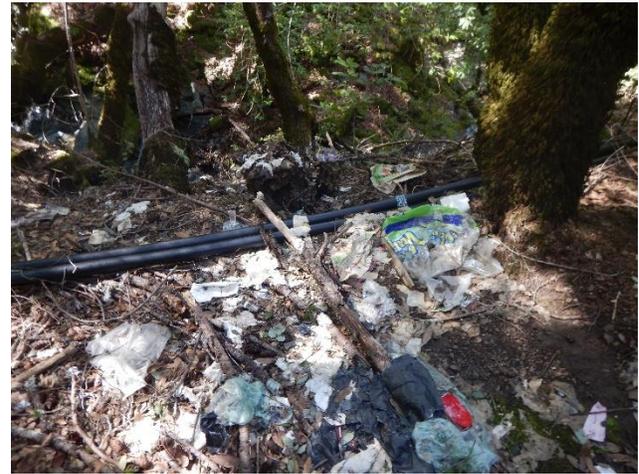
Photo 32 – Refuse along POD pipeline pathway
